PROTEK 334I BY INOMETA

**THE CFRP RECOVERING LAYER  
FOR RUBBER COVERED ROLLERS.**

PROTEK 3341 IS A PROTECTIVE RECOVERING LAYER THAT PRESERVES THE STRUCTURAL AND PERFORMANCE CHARACTERISTICS OF YOUR CARBON FIBER ROLLER CORES.

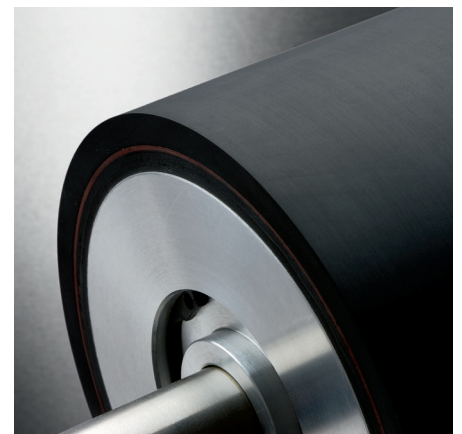
heat resistant up to 160°C – both are optimal properties for vulcanizing new rubber covers. PROTEK 334I is easy to clean with normal cleaners and solvents such as acetone, ethanol or benzene. On the whole, PROTEK 334I ensures much easier handling and maximum process stability when renewing the rubber cover. Those who wish to protect their CFRP rollers should not delay and have PROTEK 334I applied during the next recovering process. All new CFRP rollers are of course available with PROTEK coating.
